DYNAMIC SEALS FOR ADVANCED HYDRAULIC SYSTEMS

Robert B. Olsen
Vought Corporation
P.O. Box 225907
Dallas, Texas 75265

August 1981

Final Report for Period July 1978 - March 1981

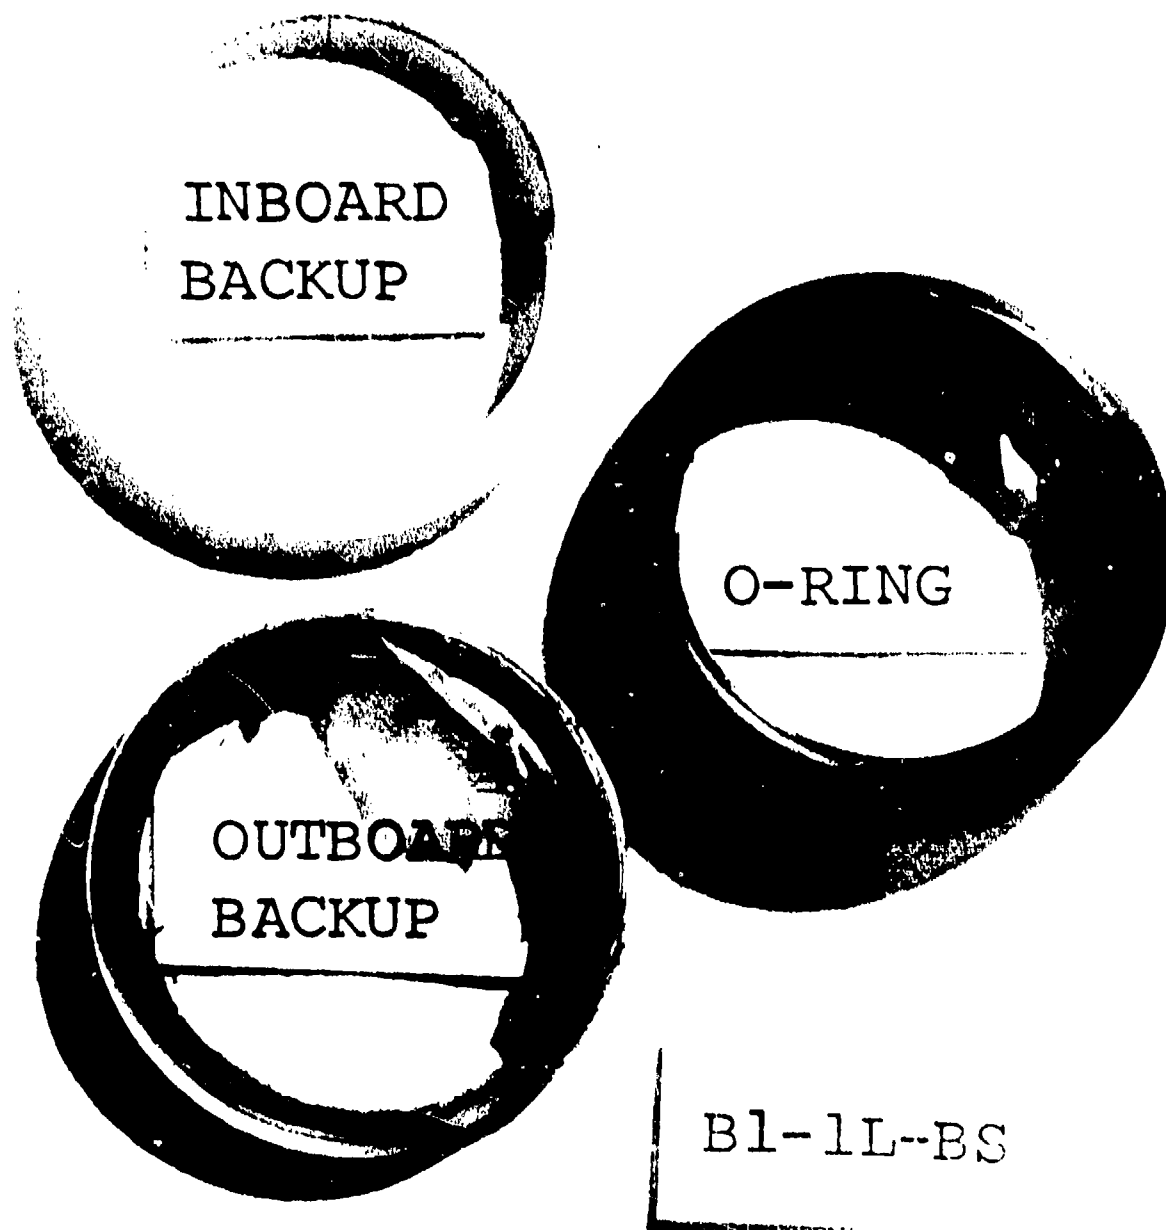
CRES END CAP: See Figure 30. The backup sample in the CRES end cap exhibited moderate to heavy wear. The rod exhibited very light wear. The O-ring was nibbled on the OD and ID. Diametral clearance was .0038. Leakage was 8 drops in 1000 cycles.

Figure 30. Candidate B1 After Backup Screening Test -
Cres End Cap Installation. O-ring condition is fair.

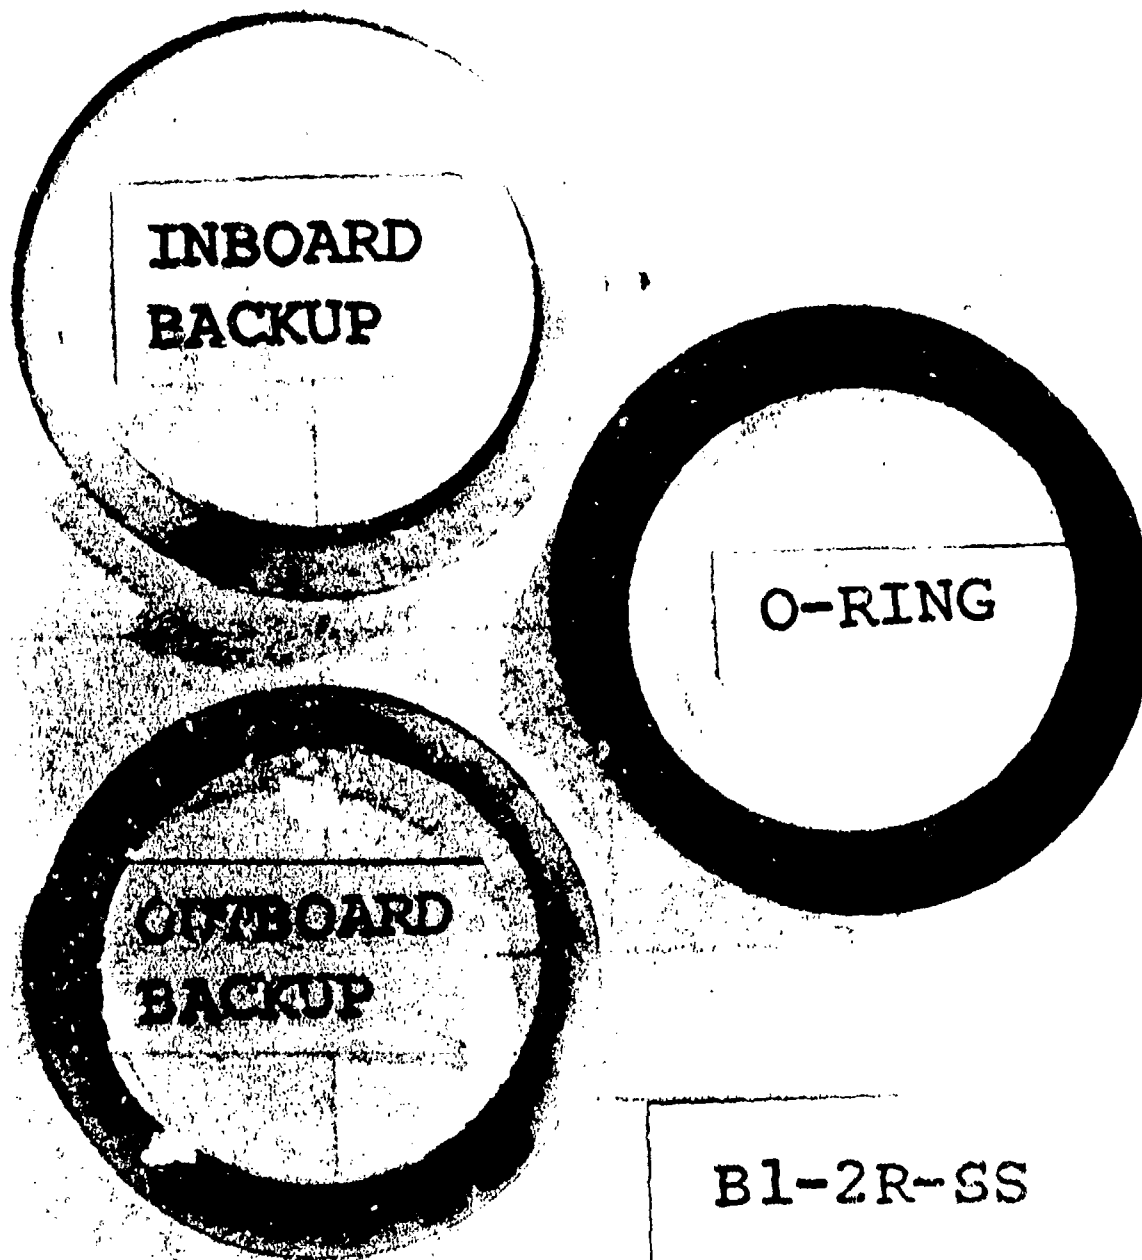
ALUMINUM-BRONZE END CAP: See Figure 31. The backup sample in the aluminum-bronze end cap exhibited moderate wear. The O-ring was not damaged. No leakage was observed in 1000 cycles. Diametrical clearance was .0036

Figure 31. Candidate B1 After Backup Screening Test - Aluminum Bronze End Cap Installation. O-ring condition is good.

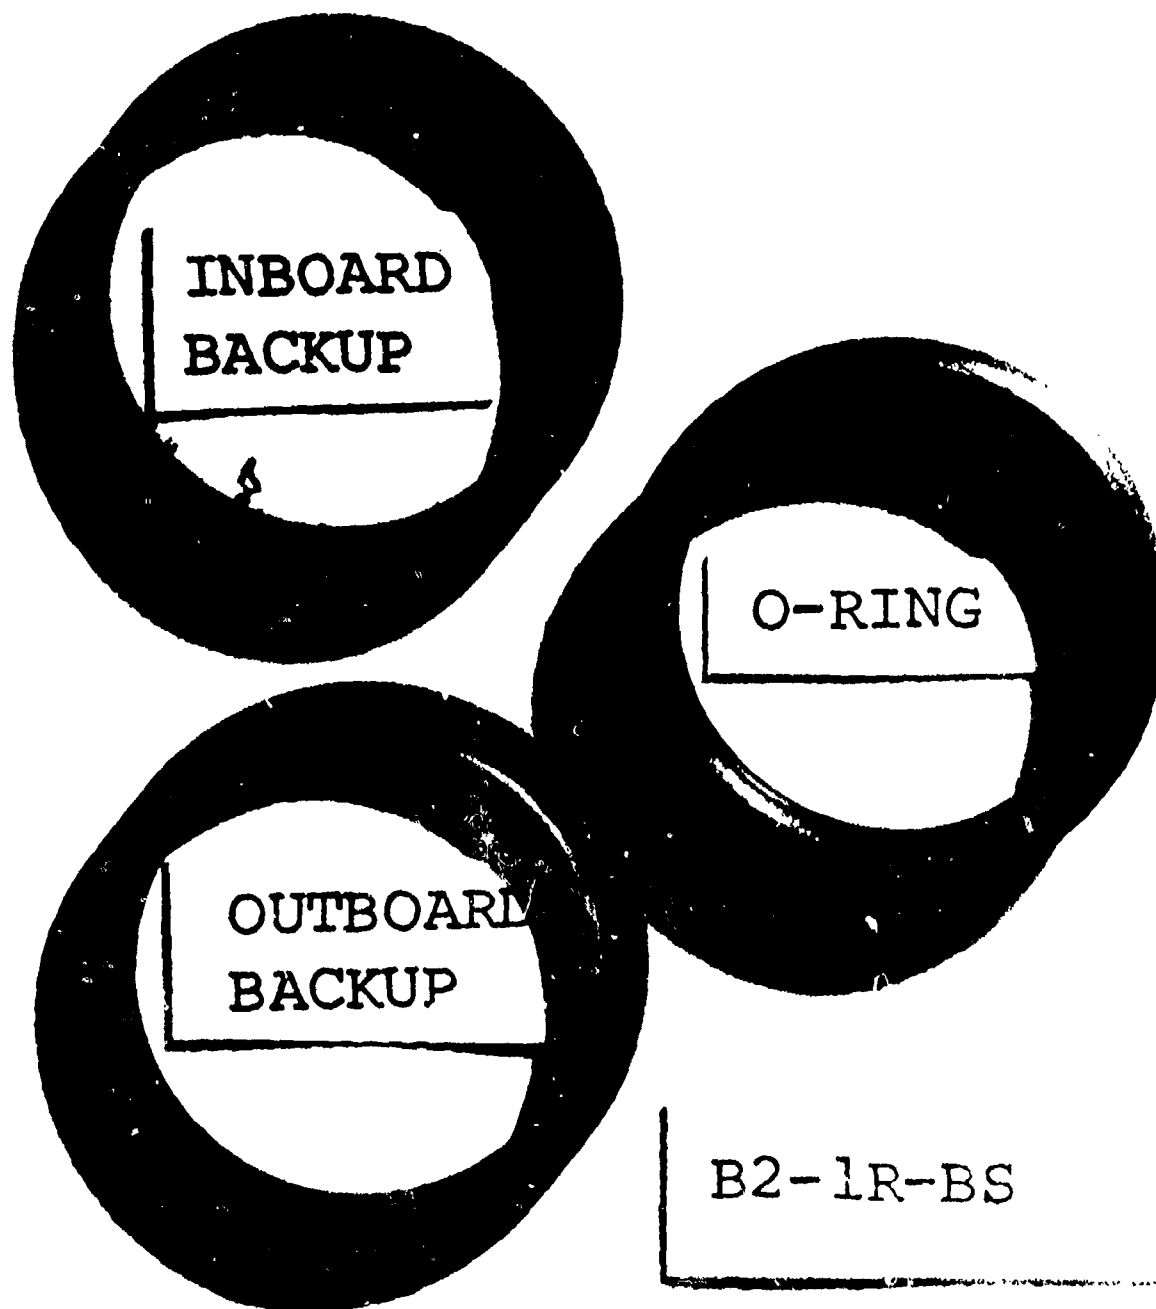
Figure 32. Candidate B1 After 3.30×10^6 Endurance Cycles With No Impulse Testing - Aluminum Bronze End Cap Installation. O-ring condition is good.

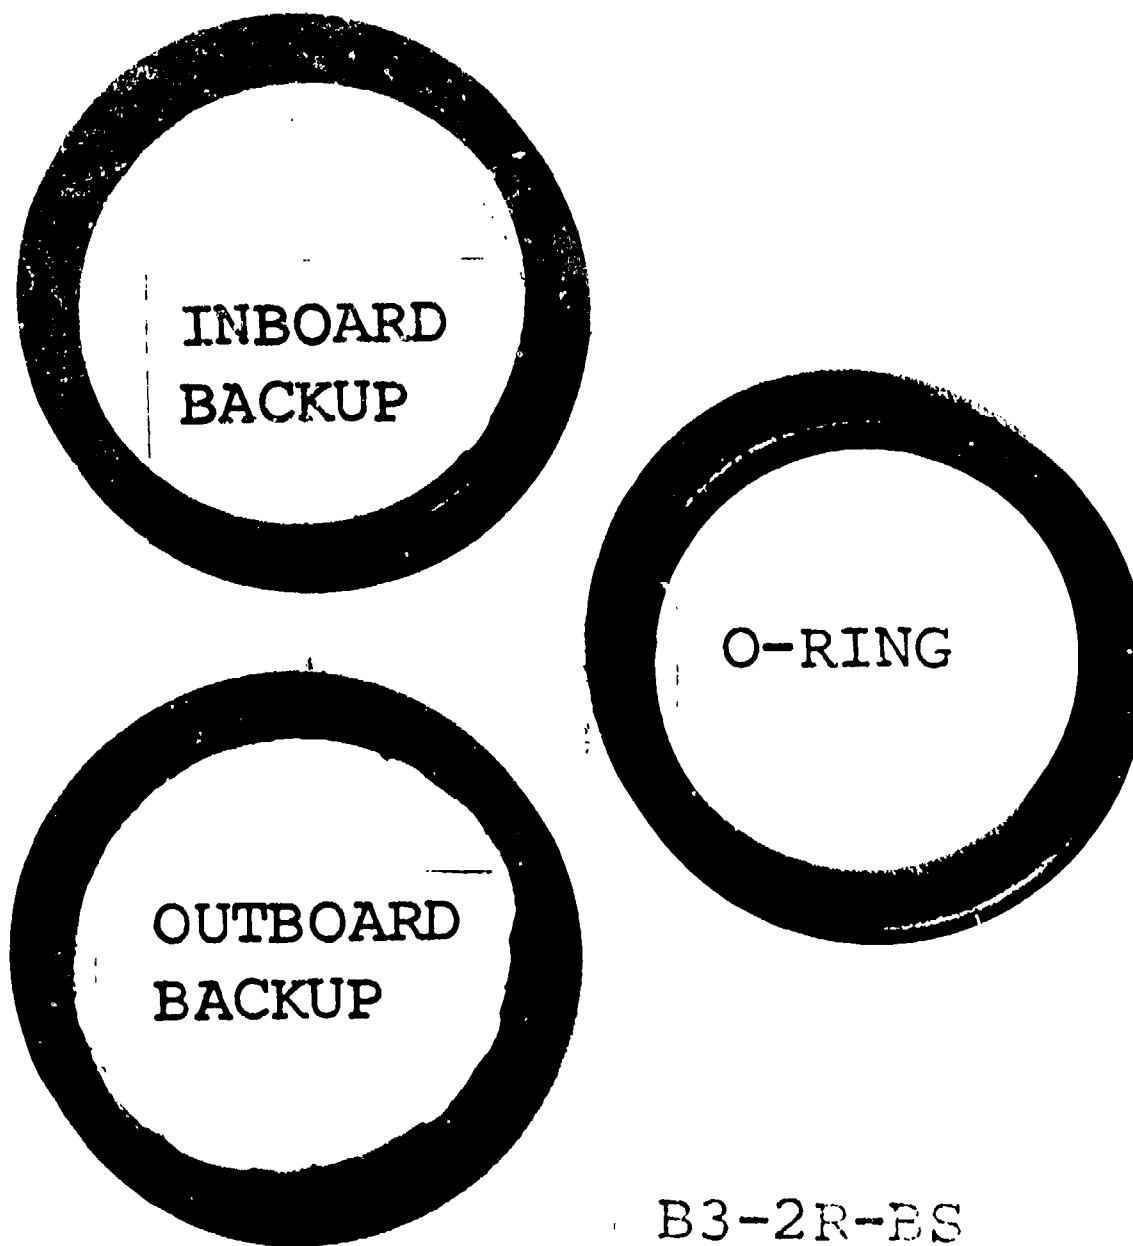
Figure 33. Candidate B2 After Backup Screening Test.
O-ring condition is good.

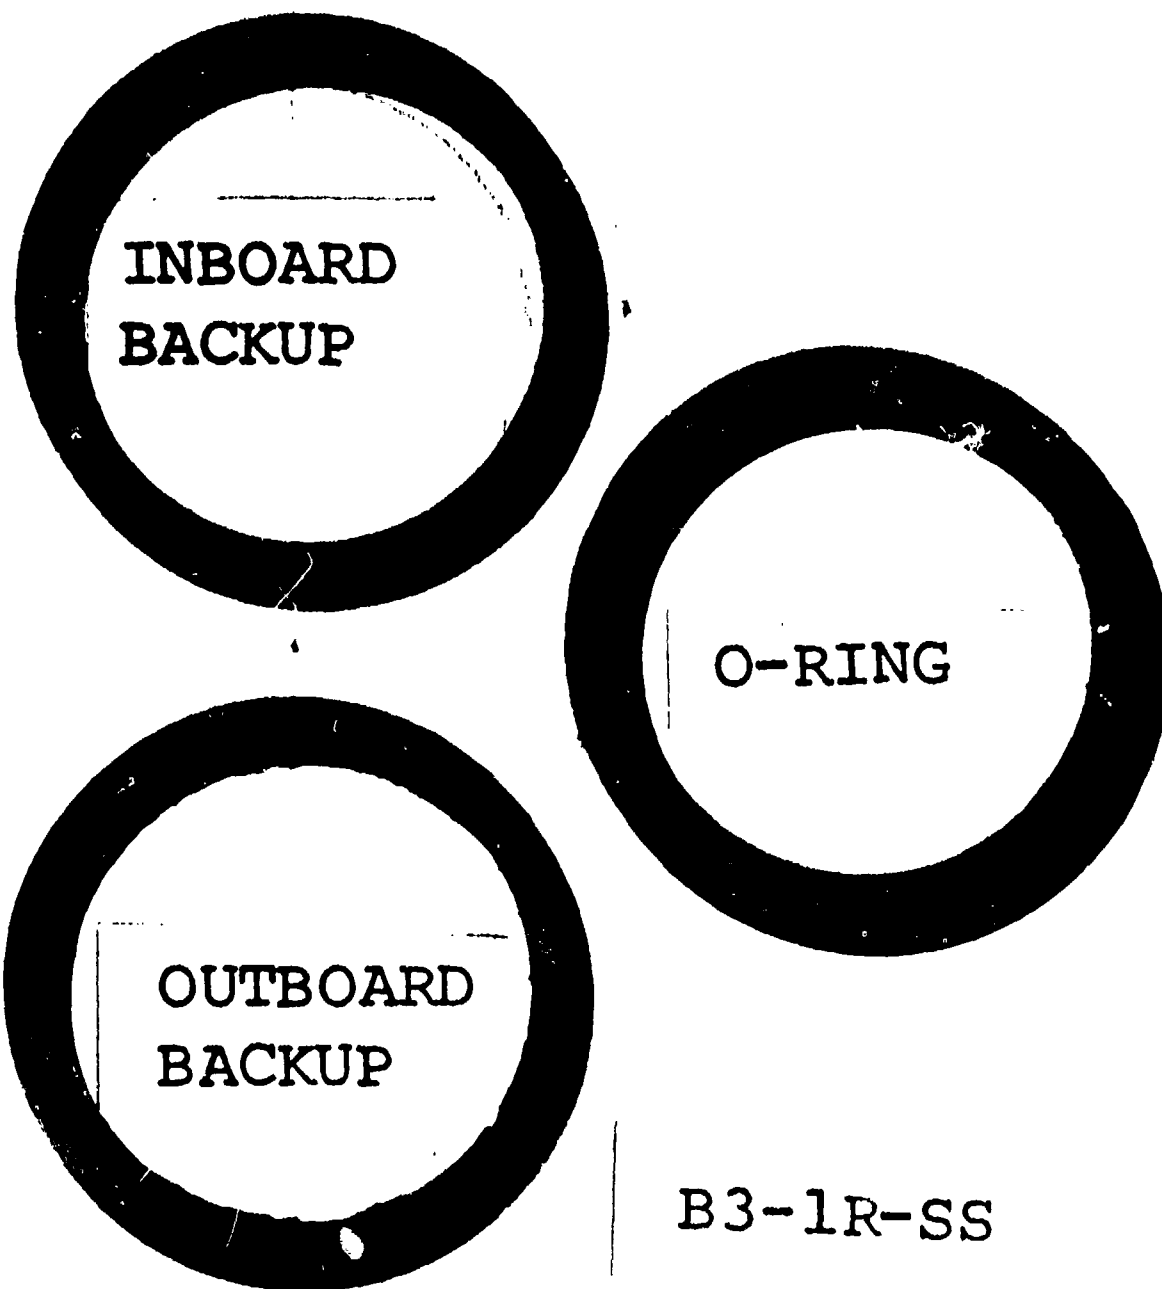
Figure 34. Candidate B3 After Backup Screening Test.
O-ring condition is excellent.

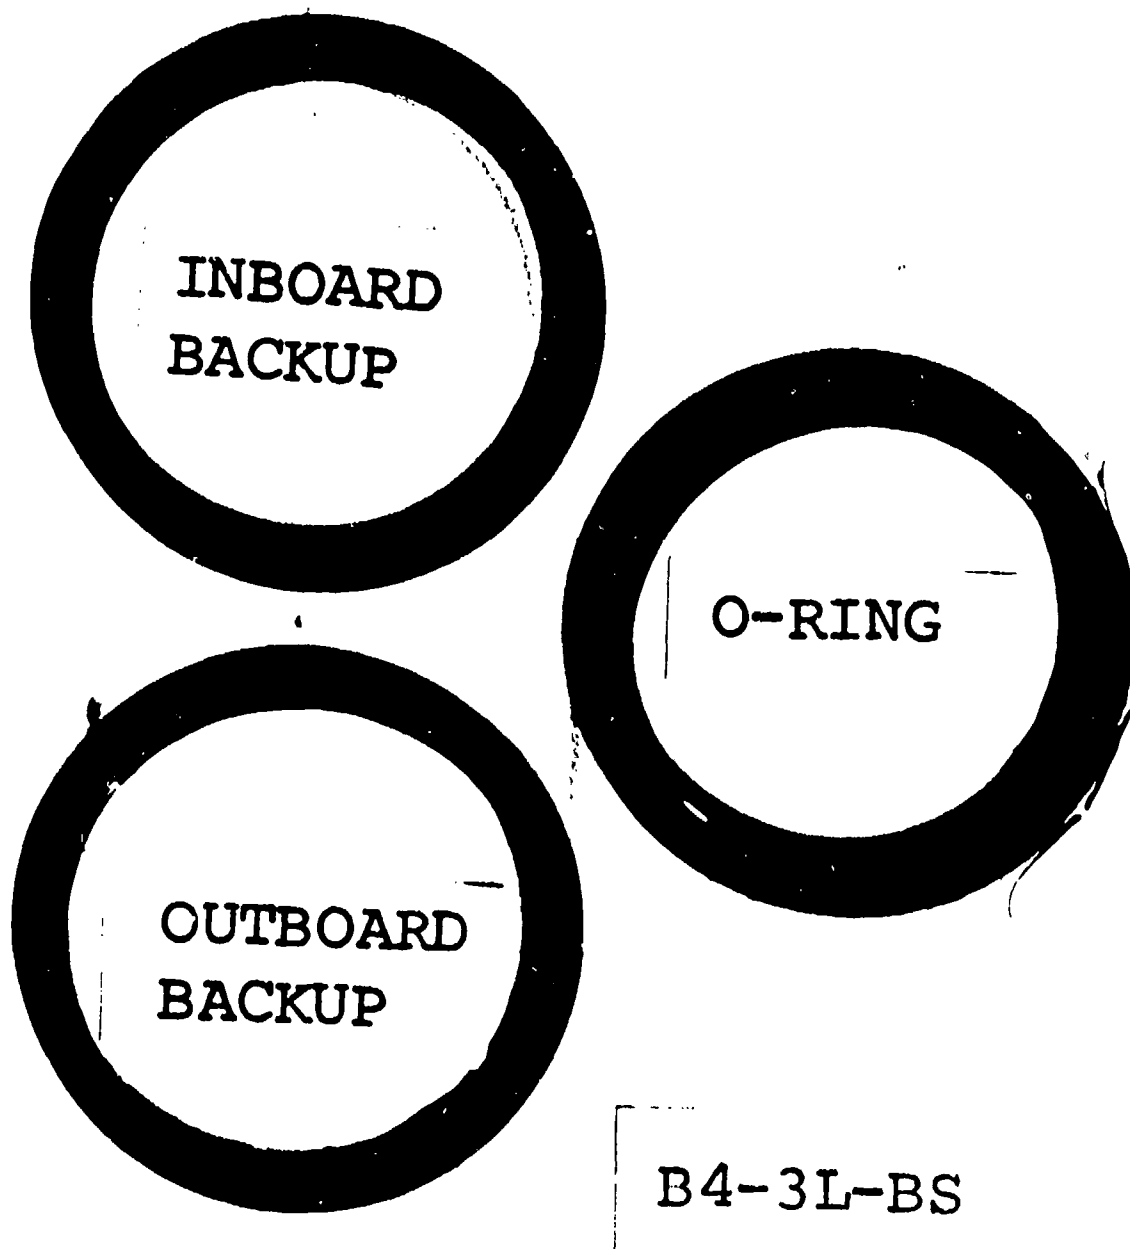
Figure 35. Candidate B3 After 3.30×10^6 Endurance Cycles with no Impulse Testing. O-ring condition is excellent.

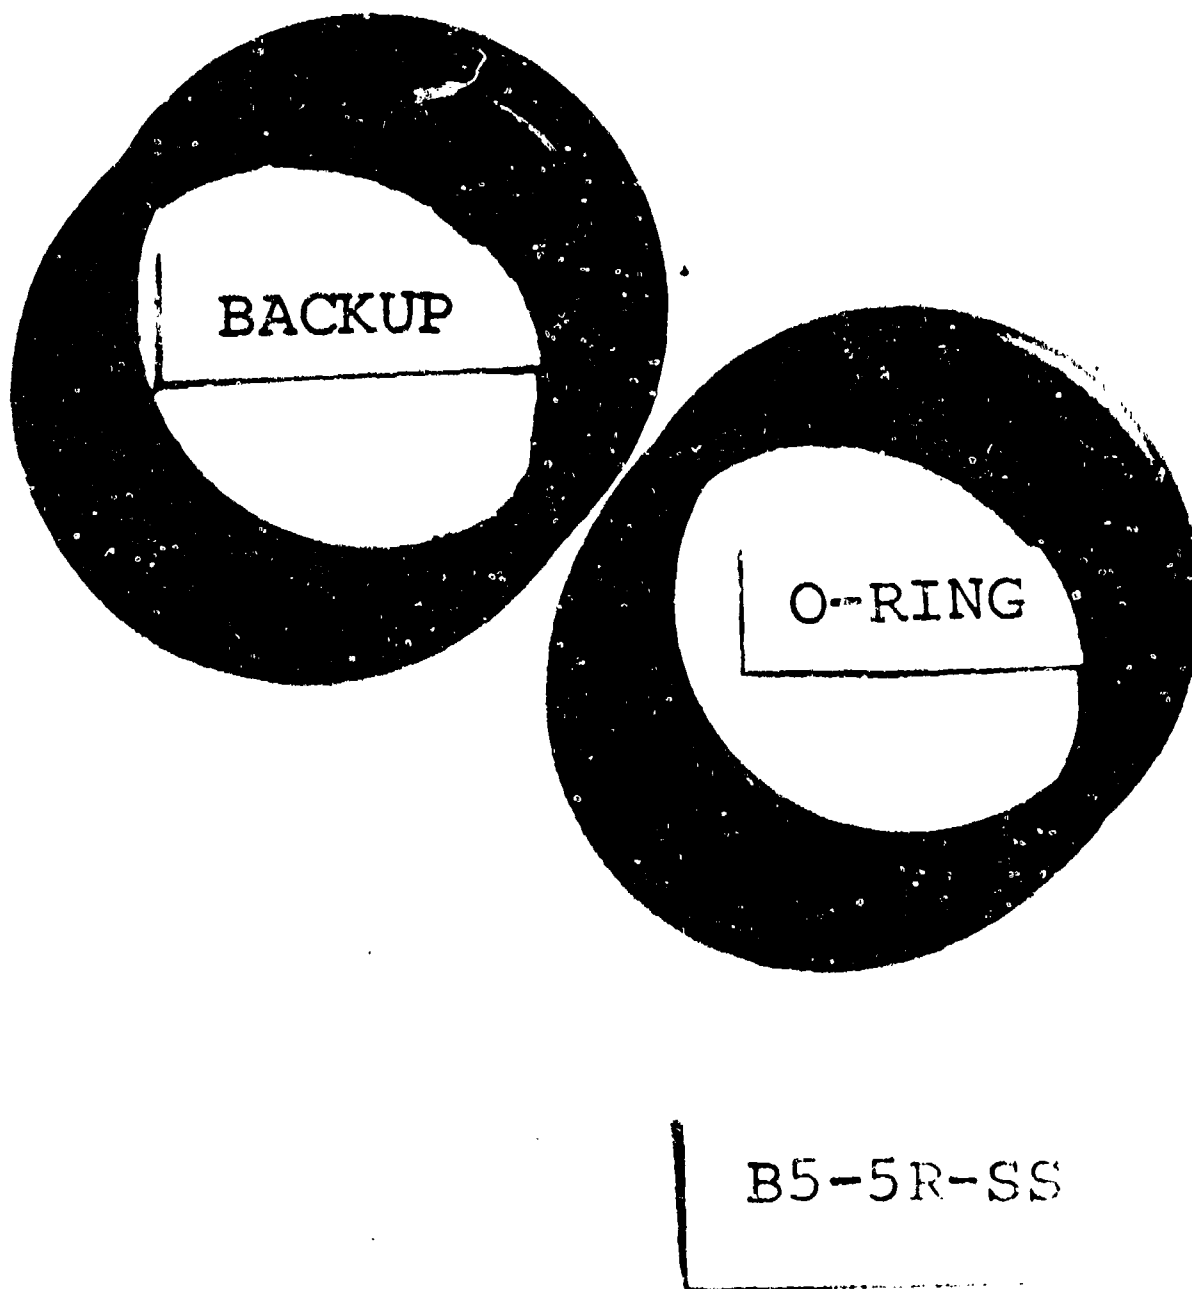
Figure 37. Candidate B5 After Backup Screening Test.
O-ring is nibbled, condition is poor.

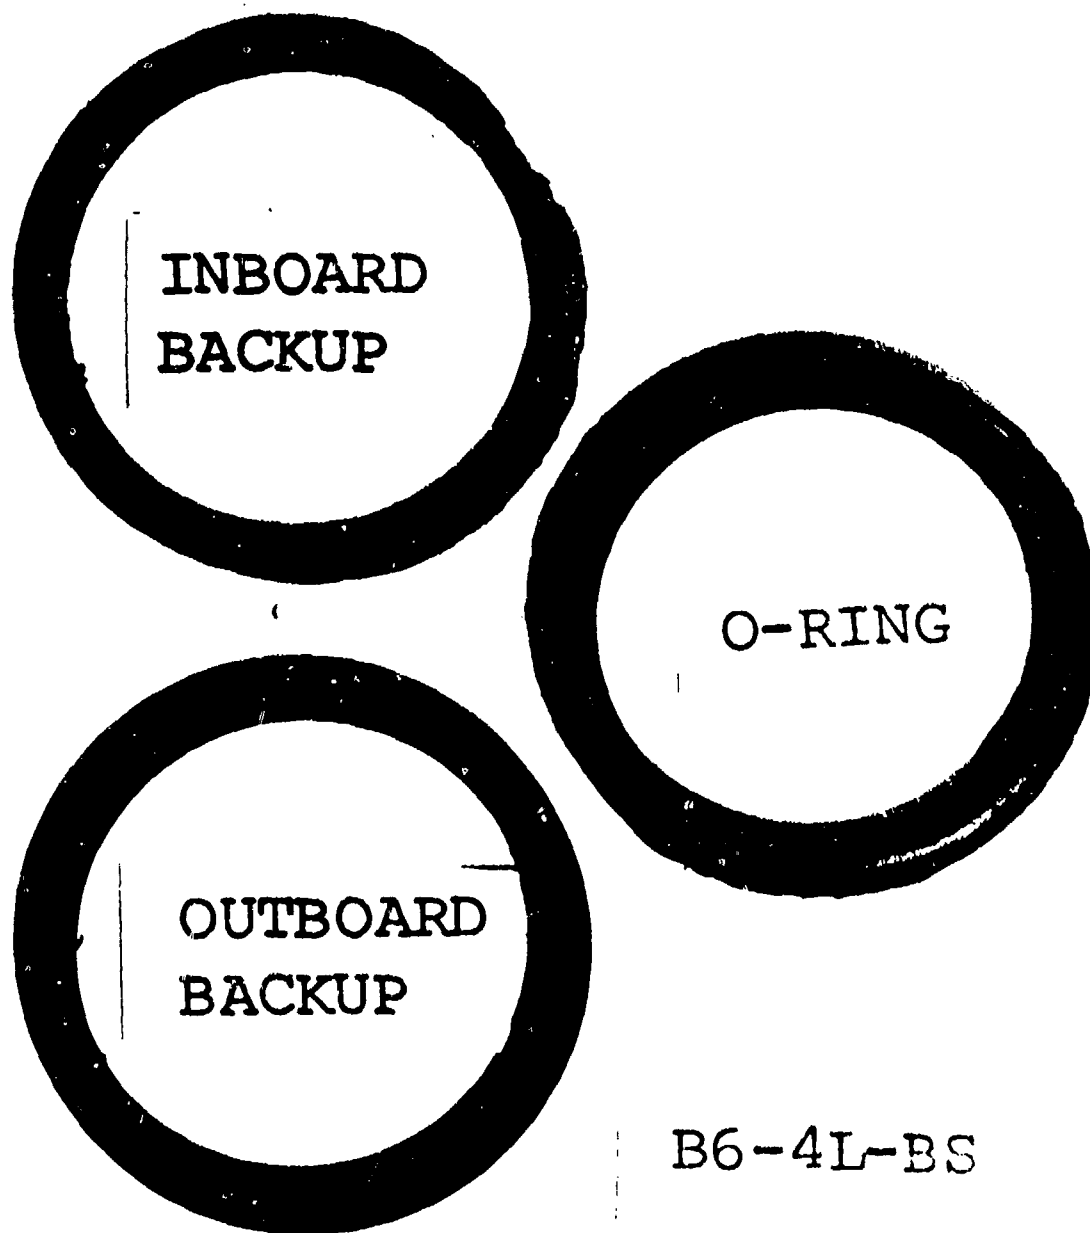
Figure 38. Candidate B5 After 3.30×10^6 Endurance Cycles With No Impulse Testing. O-ring condition is poor.

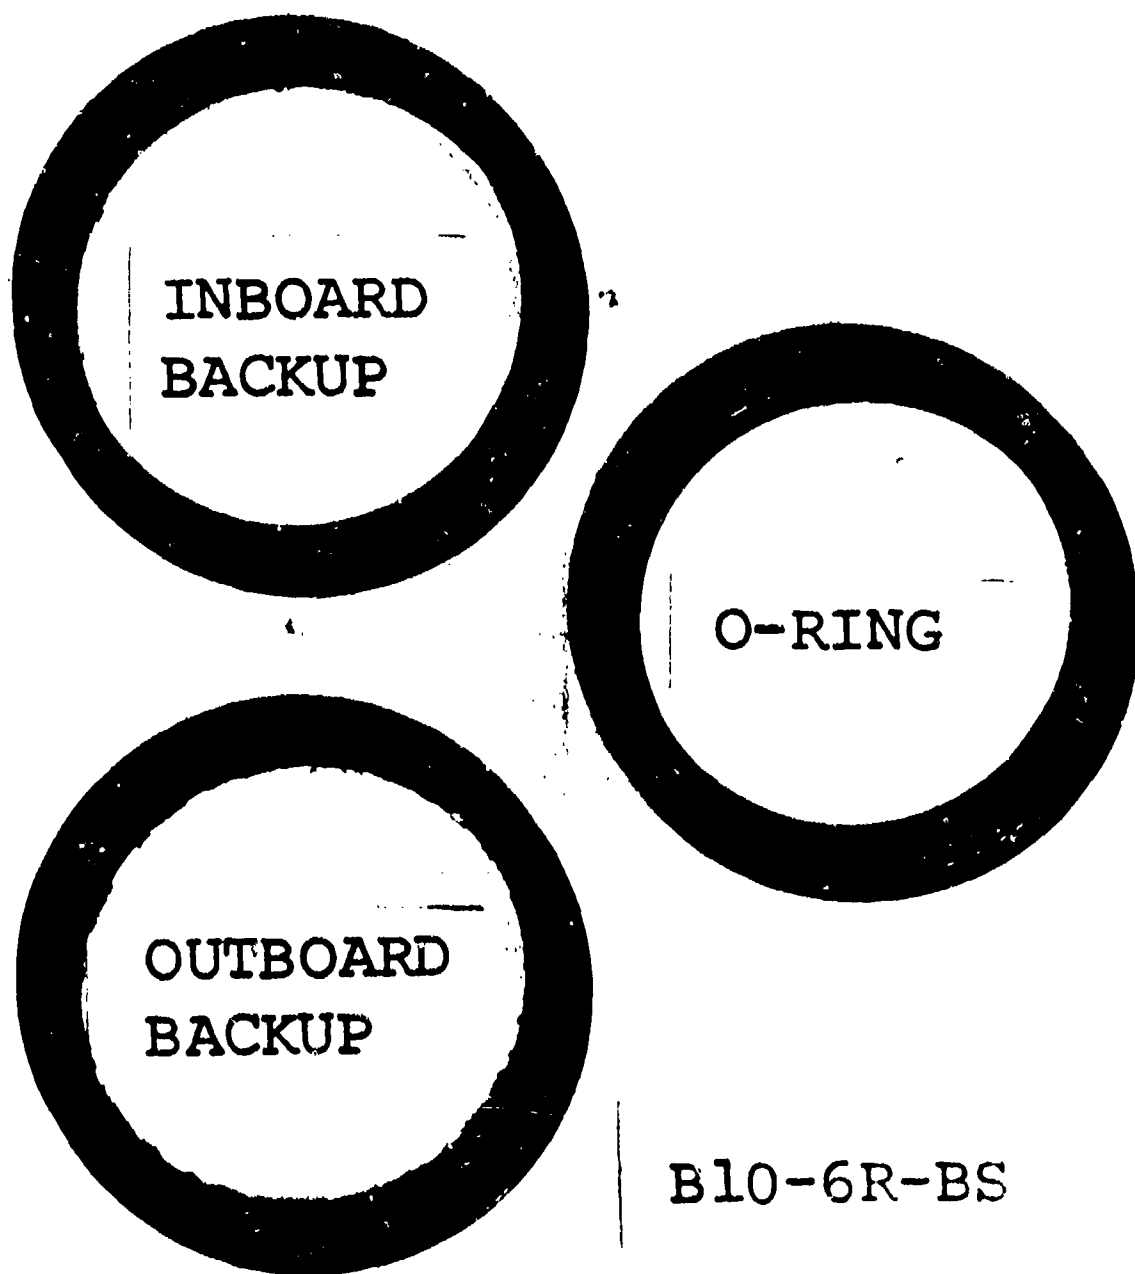
Figure 43. Candidate B9 After 3.30×10^6 Endurance Cycles With No Impulse Testing. O-ring condition is fair.

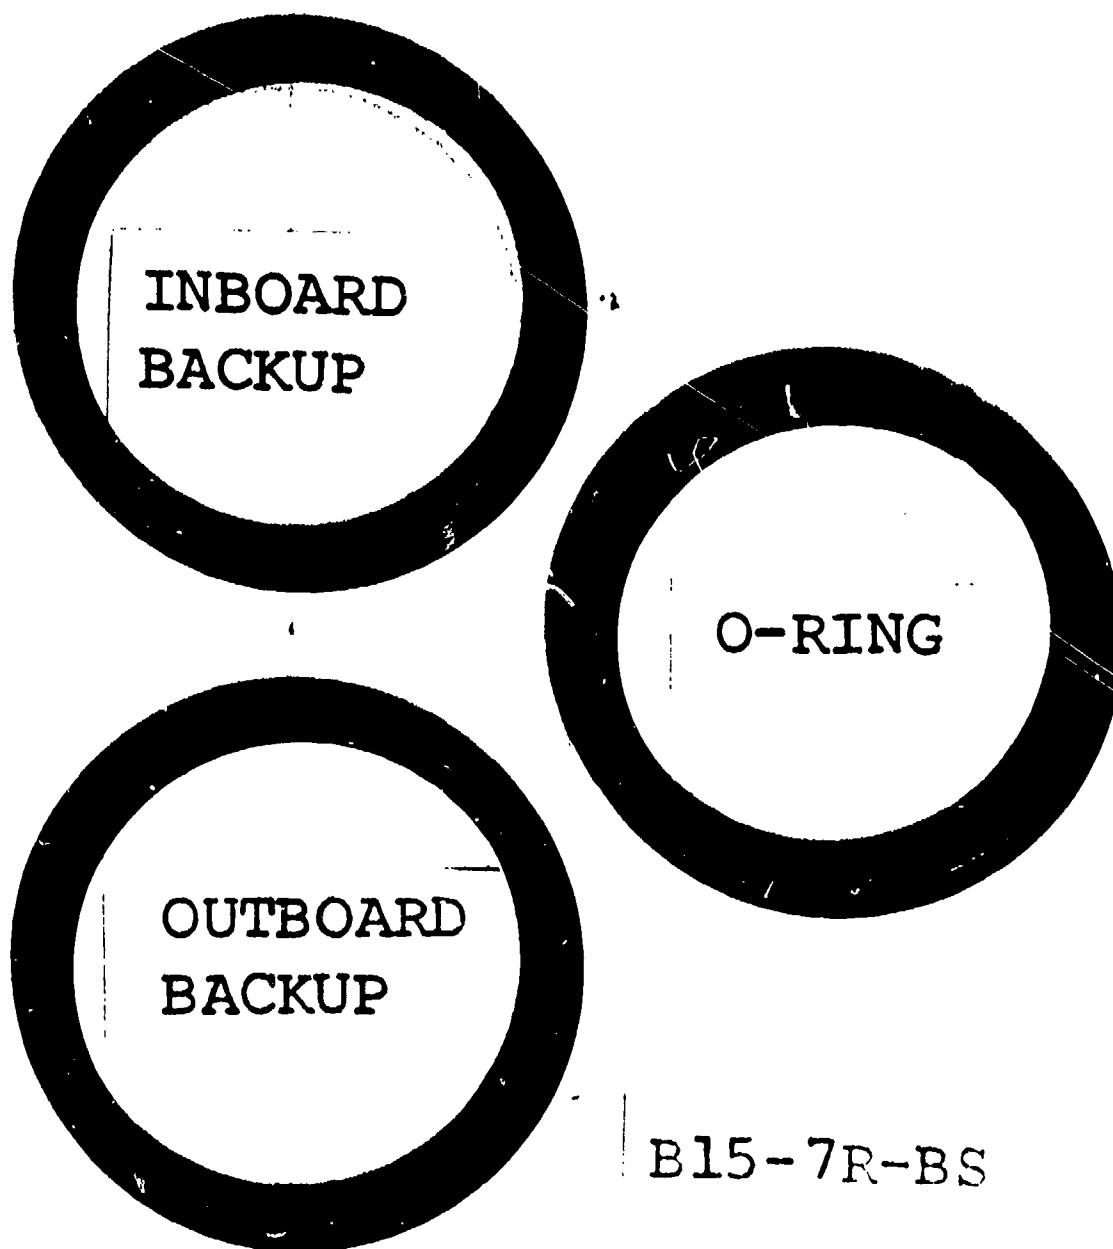
Figure 44. Candidate B10 After Backup Screening Test. Concave shape backup of Tetralon 720 has little wear. O-ring condition is poor with nibbling around the entire ID.

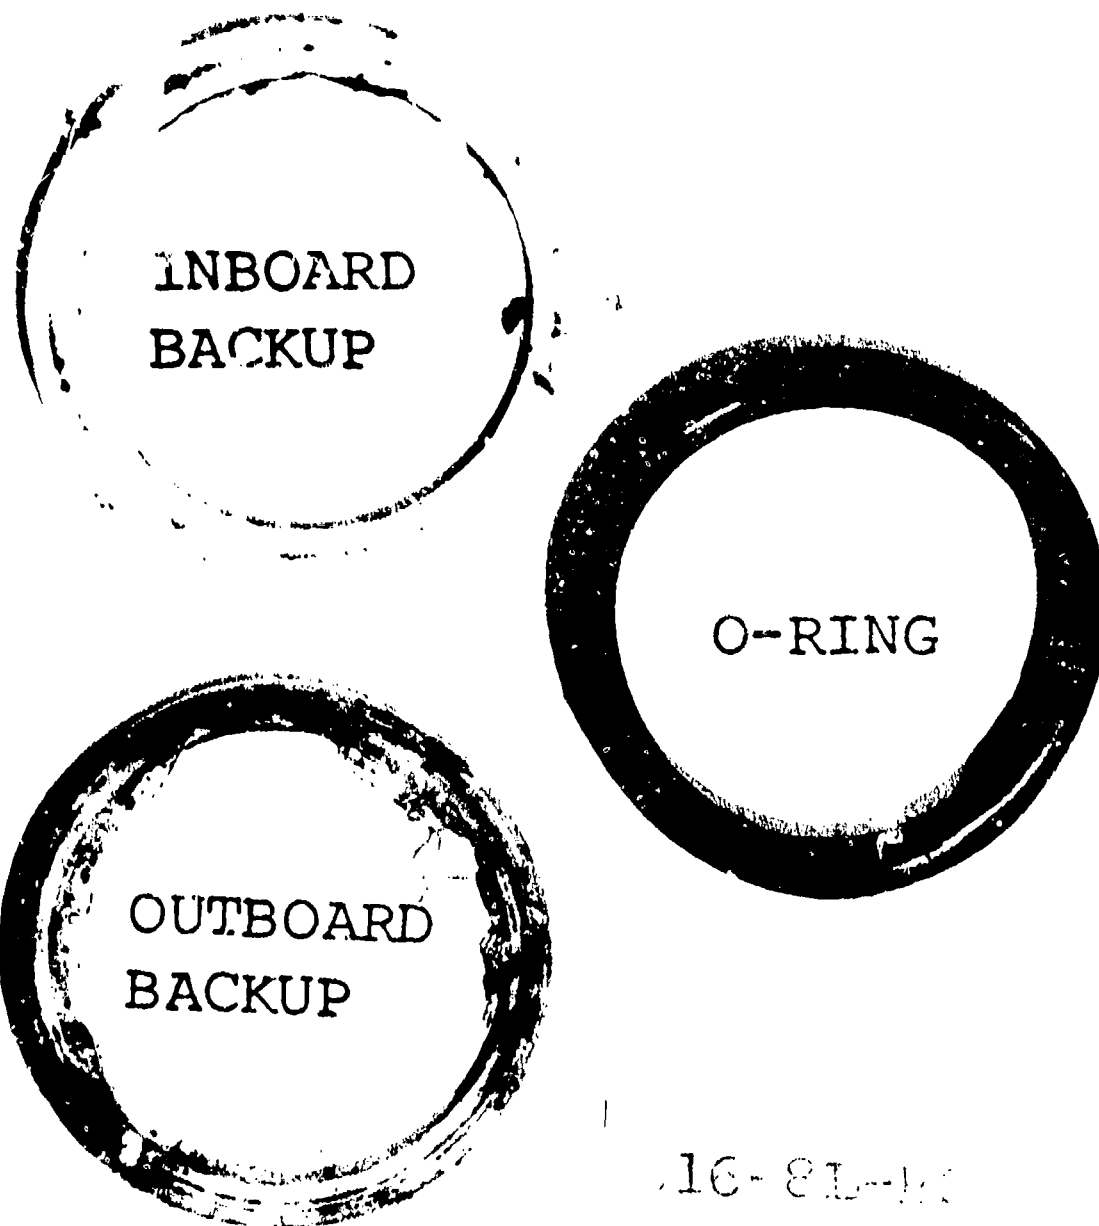
Figure 45. Candidate B15 After Backup Screening Test. O-ring suffered catastrophic failure due to rod scoring. Polyimide (SP-1) backups are undamaged. Exclusive of scoring damage, O-ring has severe nibbling around ID.

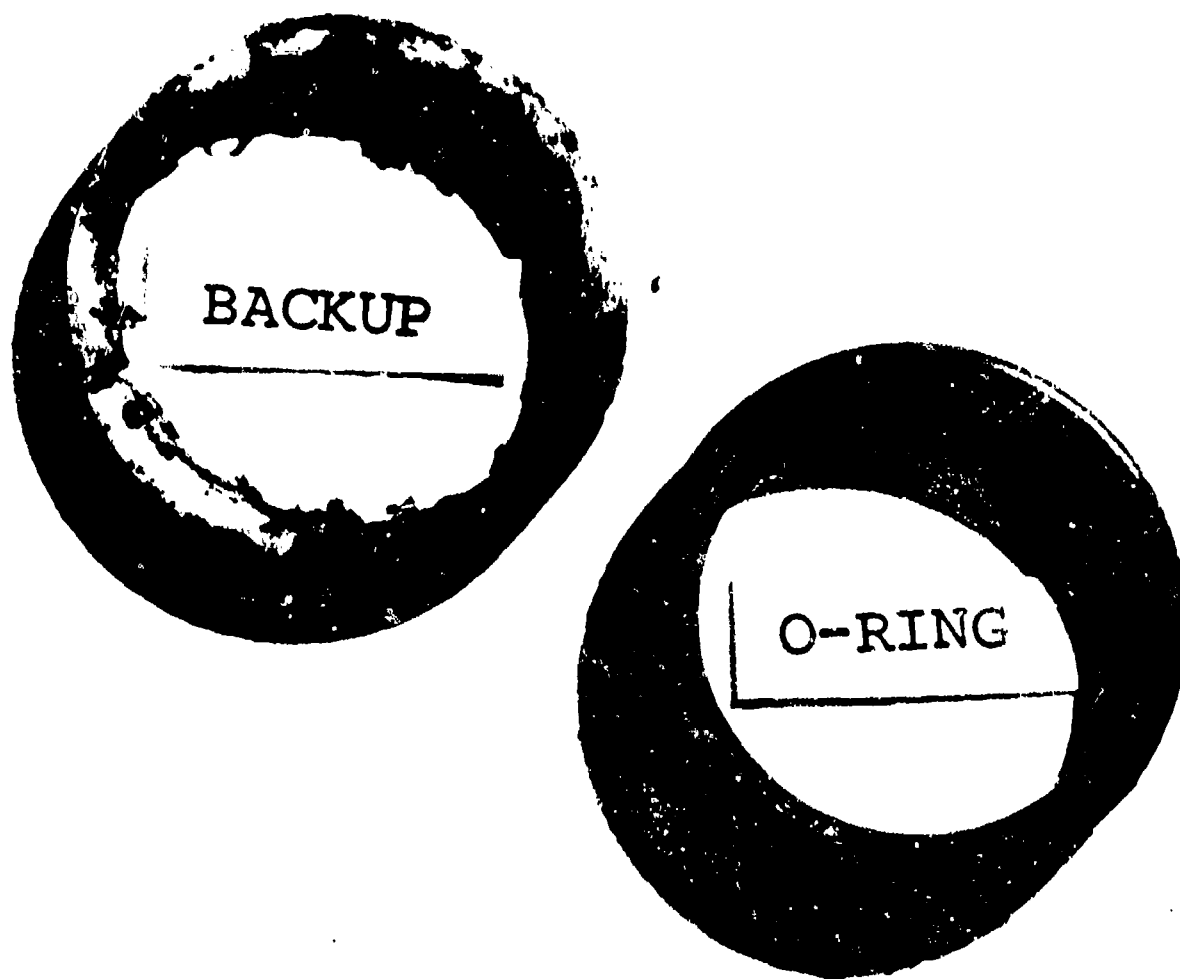
Figure 46. Candidate B16 After Backup Screening Test.
O-ring has twisted, condition is fair.

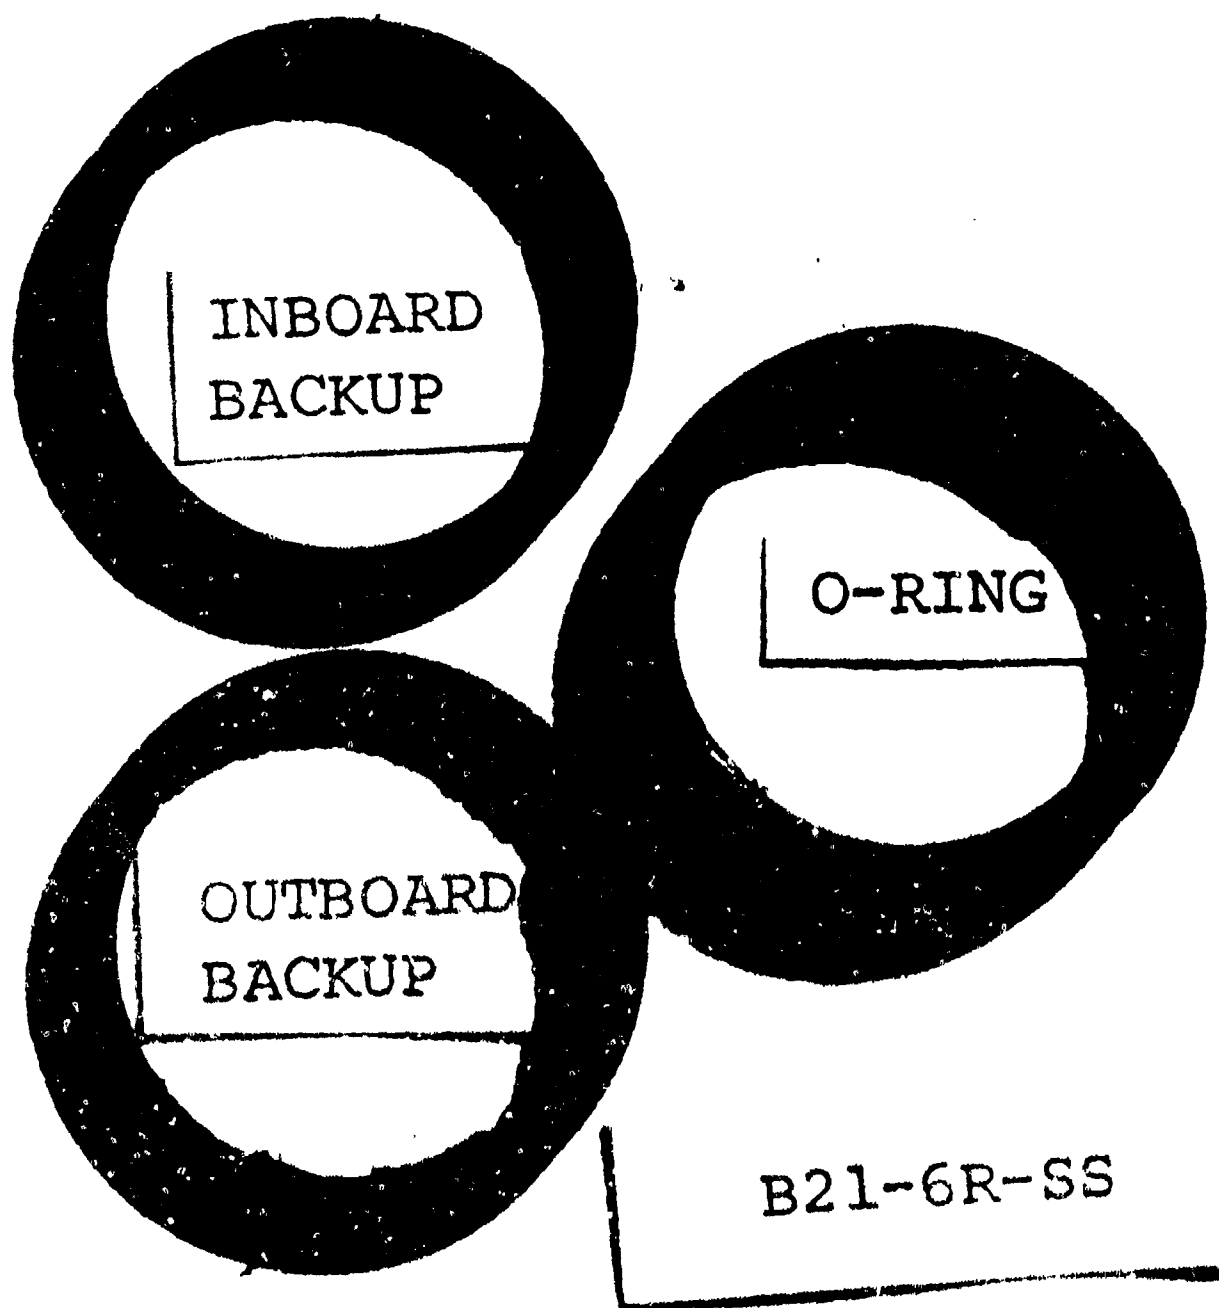
B21-71

Figure 52. Candidate B21 After Backup Screening Test.
O-ring condition is poor.

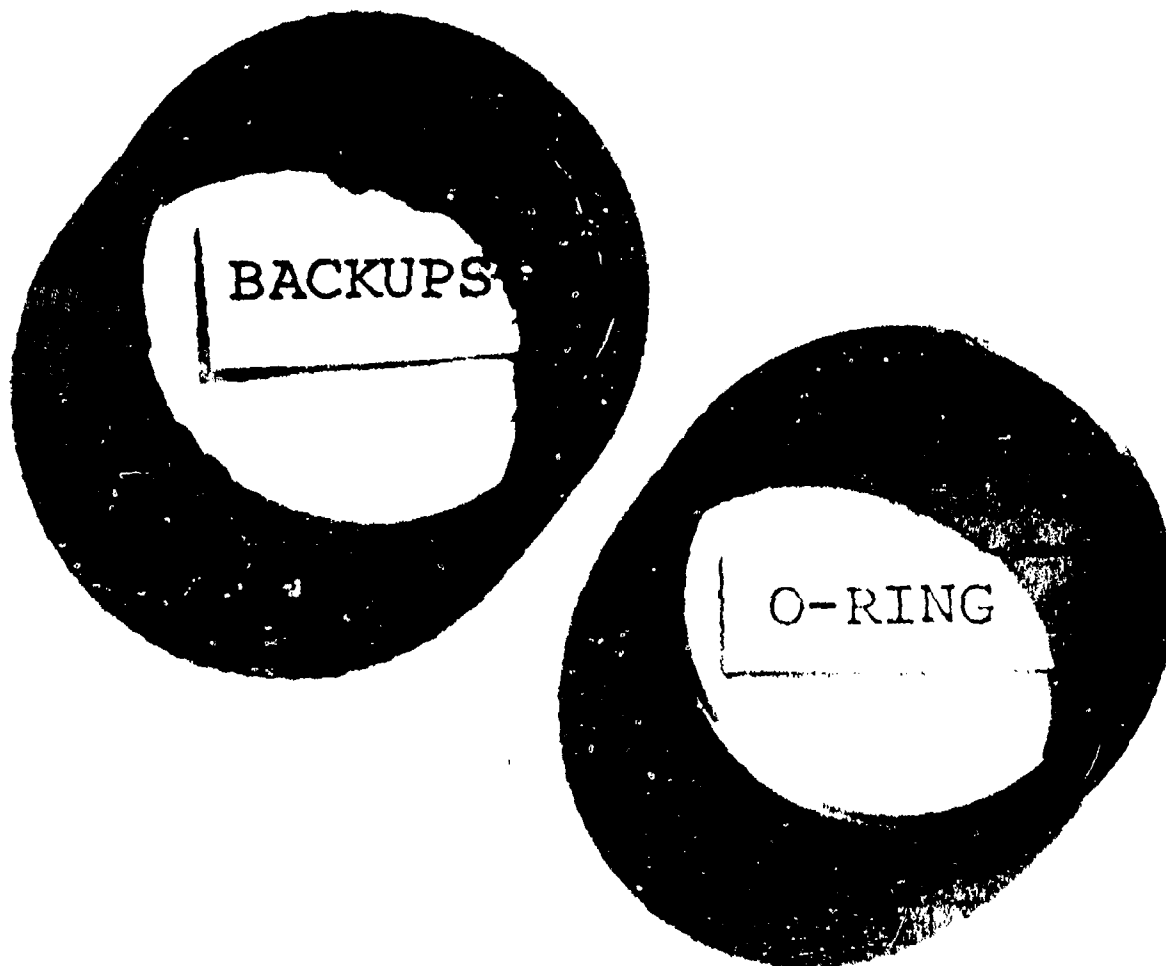
Figure 53. Candidate B21 After 3.30×10^6 Endurance Cycles With No Impulse Testing. O-ring condition is poor.

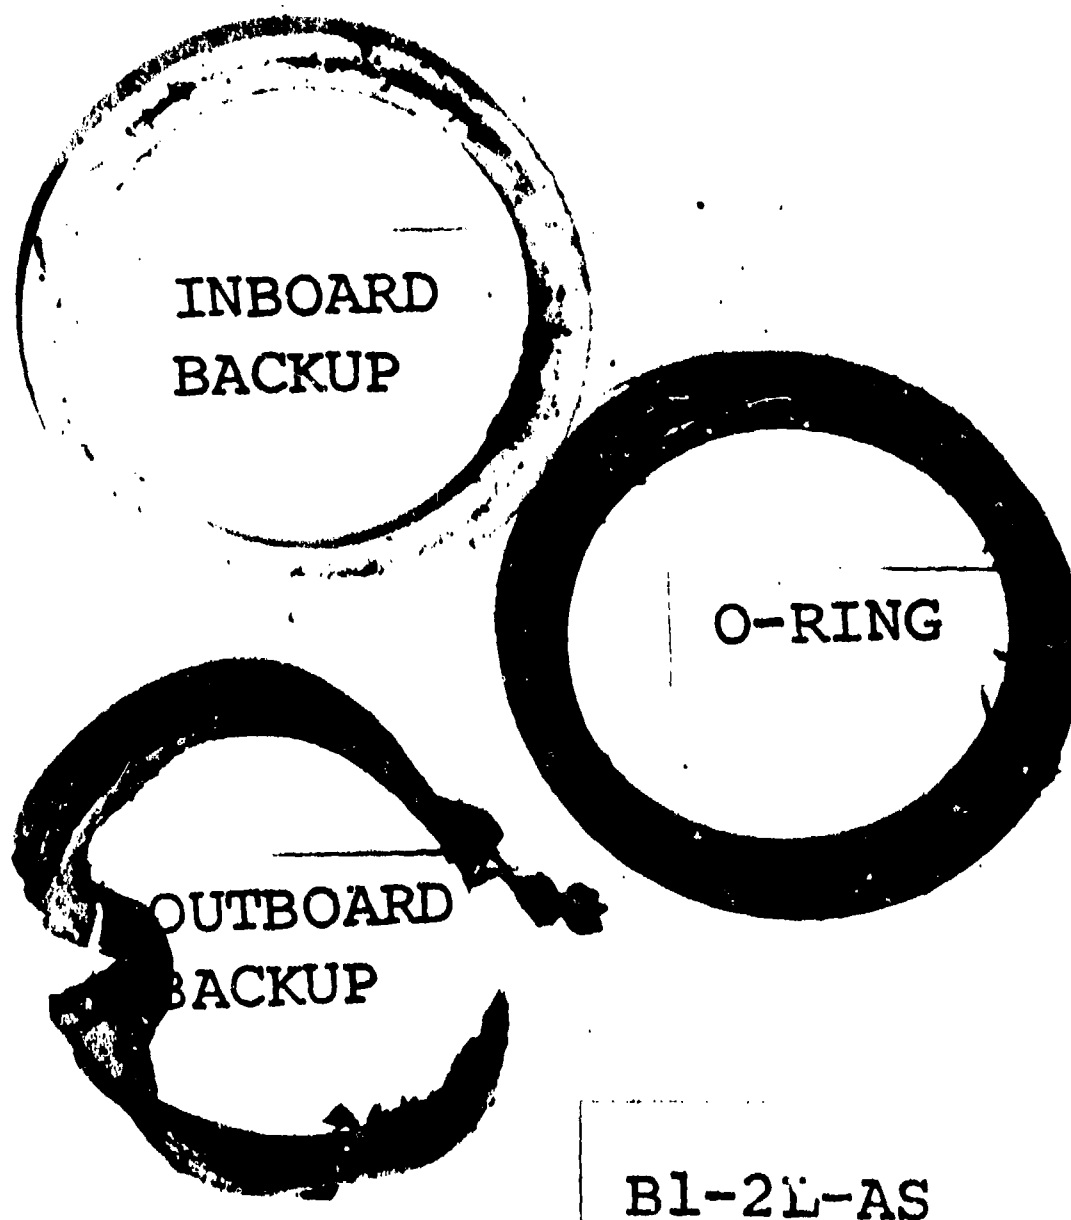
Figure 57. Typical Appearance of MS28774-214 Backups and M83461/1 O-ring Used With Scraper Candidates - No Impulse Testing. O-ring condition was good for 6 of 8 seals.

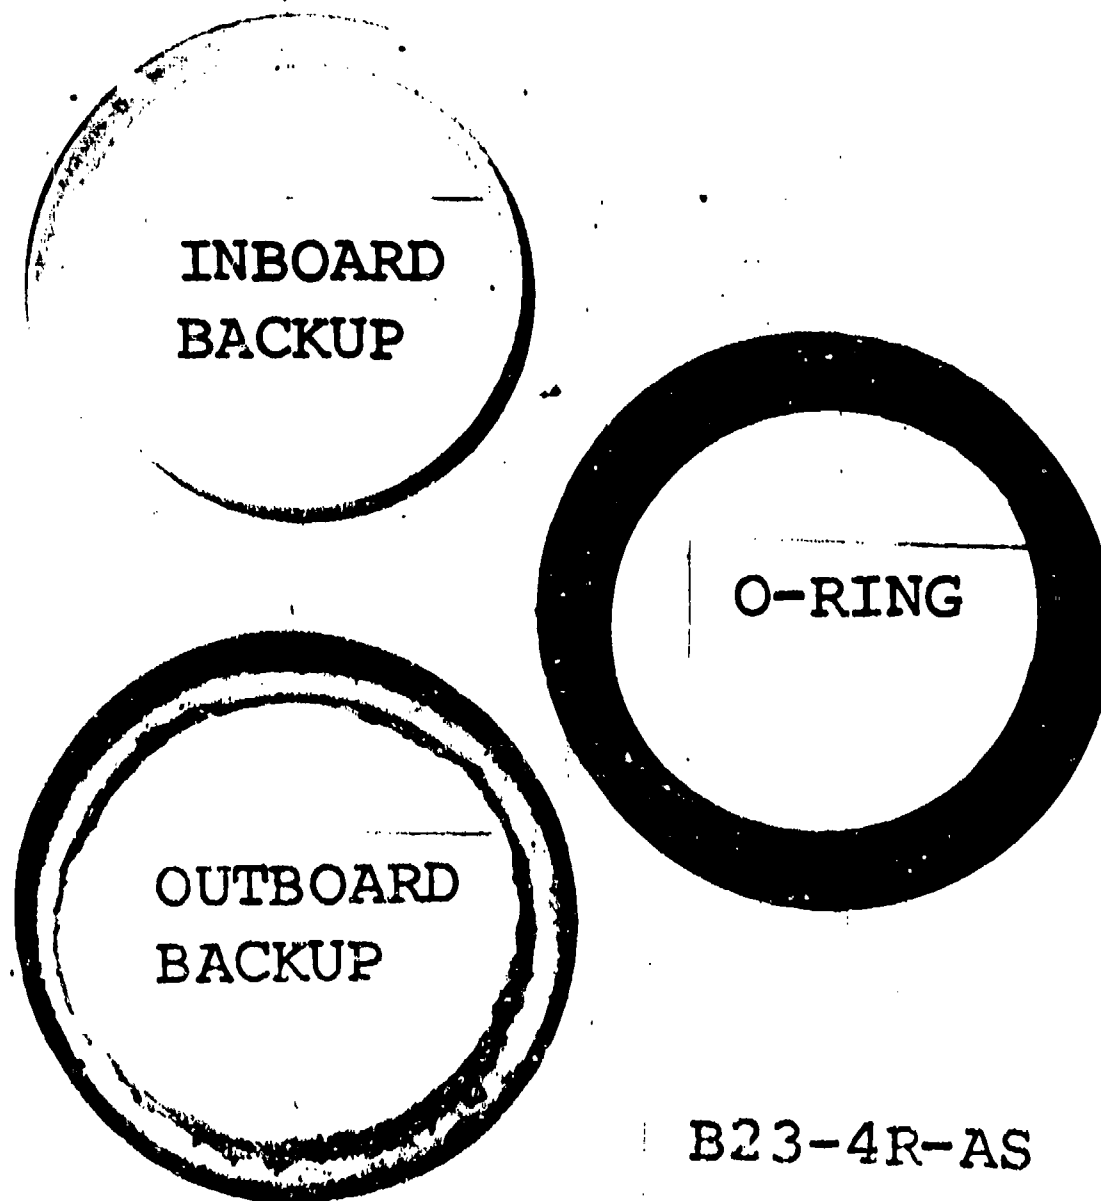
Figure 58. Typical Appearance of MS28774-214 Backups and M83461/1-214 O-ring Used With Scraper Candidates - With Impulse Testing. This seal is typical of the seven MS28774-214/M83461/-214 rod seals used with the scraper candidates during the Additional Screening Tests. Compare with Figure 57 which did not have impulse testing.
